# Chapter Seventeen – Case Studies

## Case Studies

# A Guide for Commercial Kitchen Fires

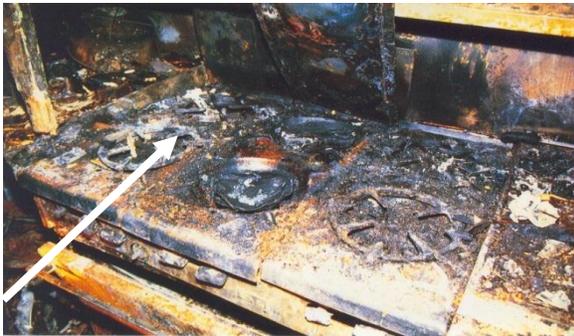
This restaurant fire occurred approximately 13 hours after closing. The left rear range burner was left in the ‘on’ position. The fire-extinguishing system probably extinguished the first fire, but did not extinguish the pilot lights.

*Range top. Fire started on the rear left burner.*

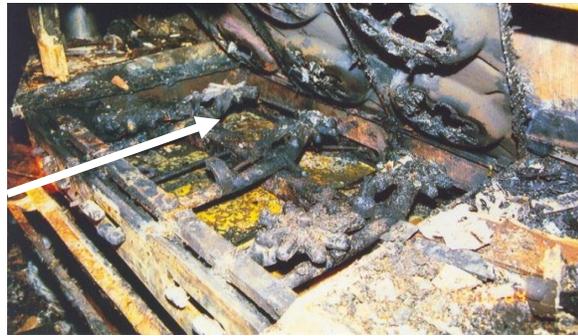
*With the burner covers lifted the amount of food debris and grease can be seen*

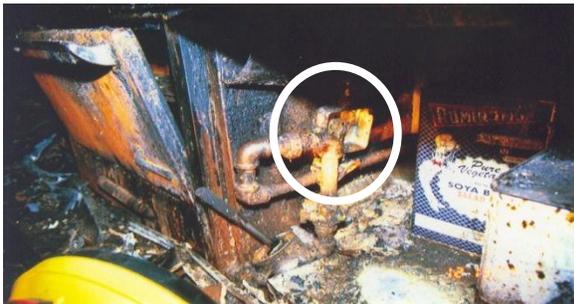
*The automatic gas shut off with the cover plate removed*

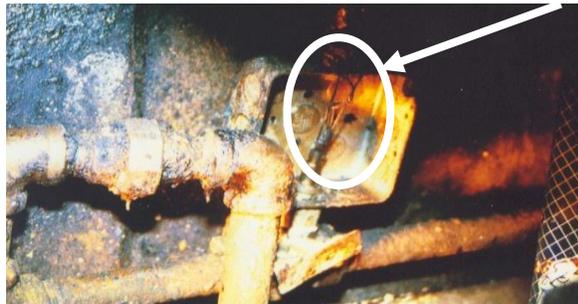
The automatic gas shut-off had been held in the ‘open’ position by bailing wire. Subsequently, the fire reignited and as the fire-extinguishing system had previously activated, there was no extinguishing agent left.

*A close up shot of the gas shut off. Observe the wire holding the valve open.*

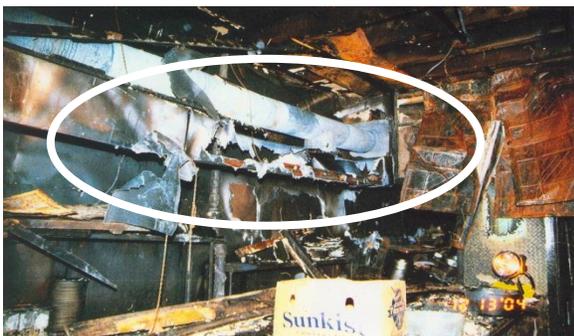
The non-compliant aluminum duct system melted, and the remaining ductwork was not clean. Accumulations of baked on grease were found in the fan housing.

*The molten aluminum duct running horizontally across the ceiling of the kitchen*

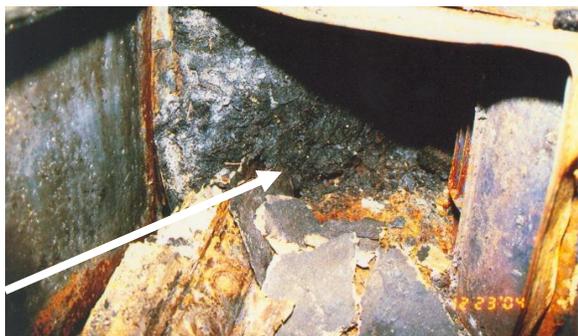
*Looking into the duct at remaining grease buildup*

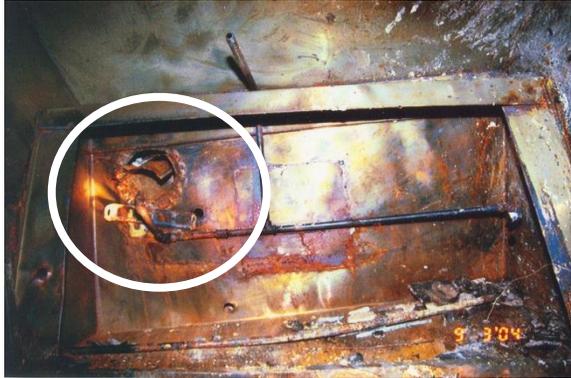
Looking up into the hood. Note the noncompliant non-welded connection of the hood to duct.

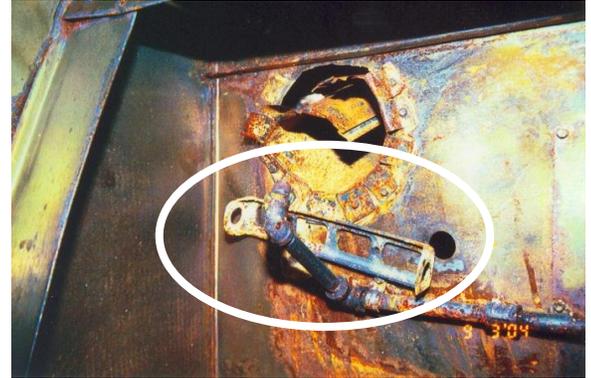
A close up of the duct opening. There is no detection system cable, only the bracket.

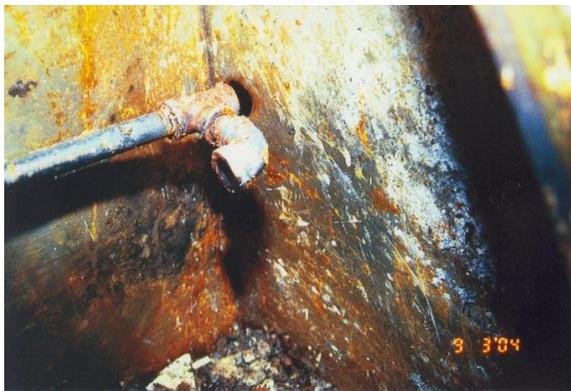
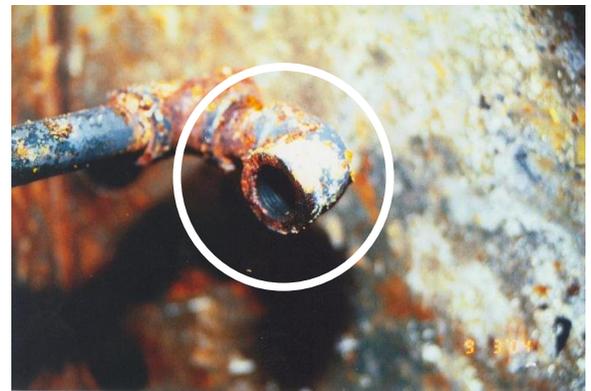
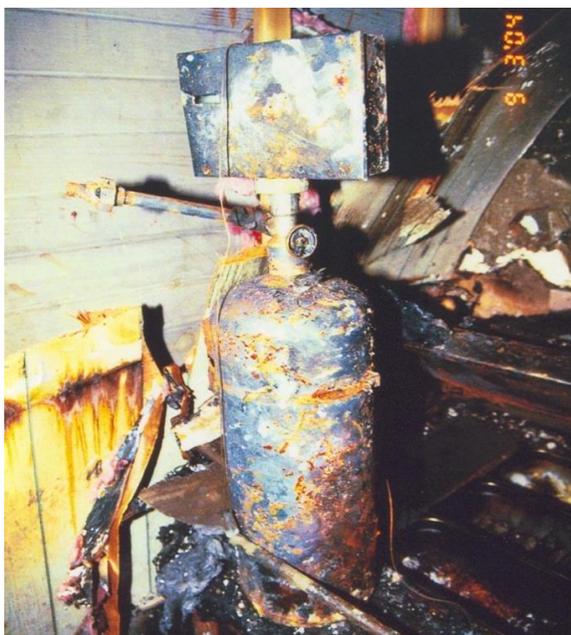
Photos of the distribution piping. From the corrosion on the threads of the piping it would appear that they were never connected.

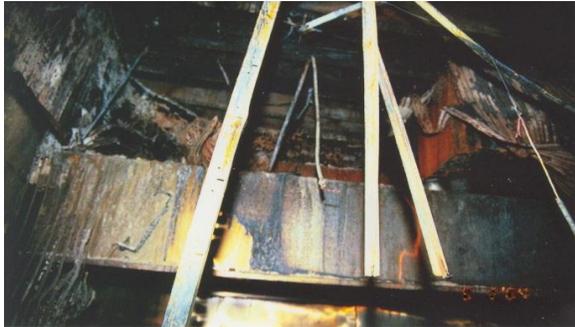
*The hood behind suspended ceiling T-bar*

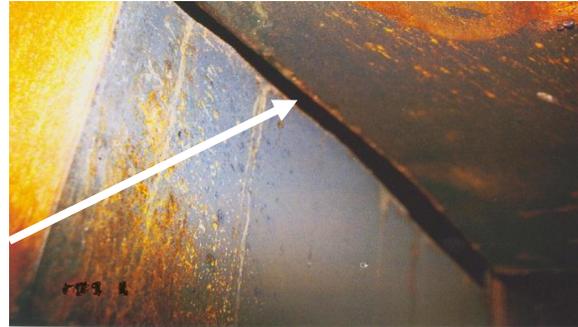
*A close up of where the vertical duct was not welded to a horizontal section of the ducting*

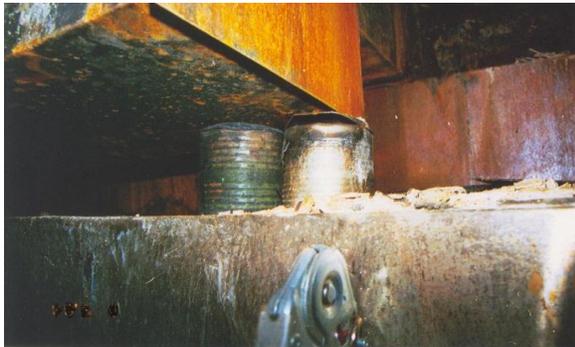
The installer told him that he would also need a new fire-extinguishing system and had removed the old one when installing the new hood. The hood was supported by one gallon metal food cans and the seams had not been welded.

*Cans holding up the edge of the hood*

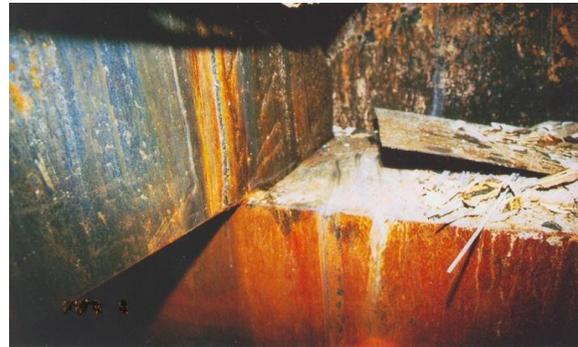
*Debris on top of one on the sections of duct*

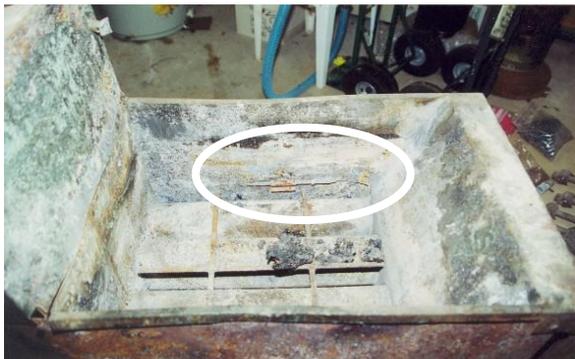
A deep fat fryer at the origin of a multi-million dollar restaurant fire. This fryer had only gas connections. Damage would likely have been limited, but the kitchen staff tried to “smother” the flames with a cookie sheet, preventing the extinguishing agent from reaching the burning oil.

*View of the capillary tube holder on the side of an oil vat*

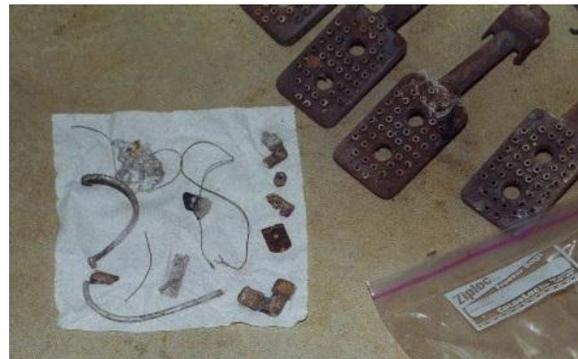
*Fryer parts found in the cabinet after the fire*
